4P07750-3

## Fire test of covering

Covering without an air gap (cavity) behind it.

Spruce profile

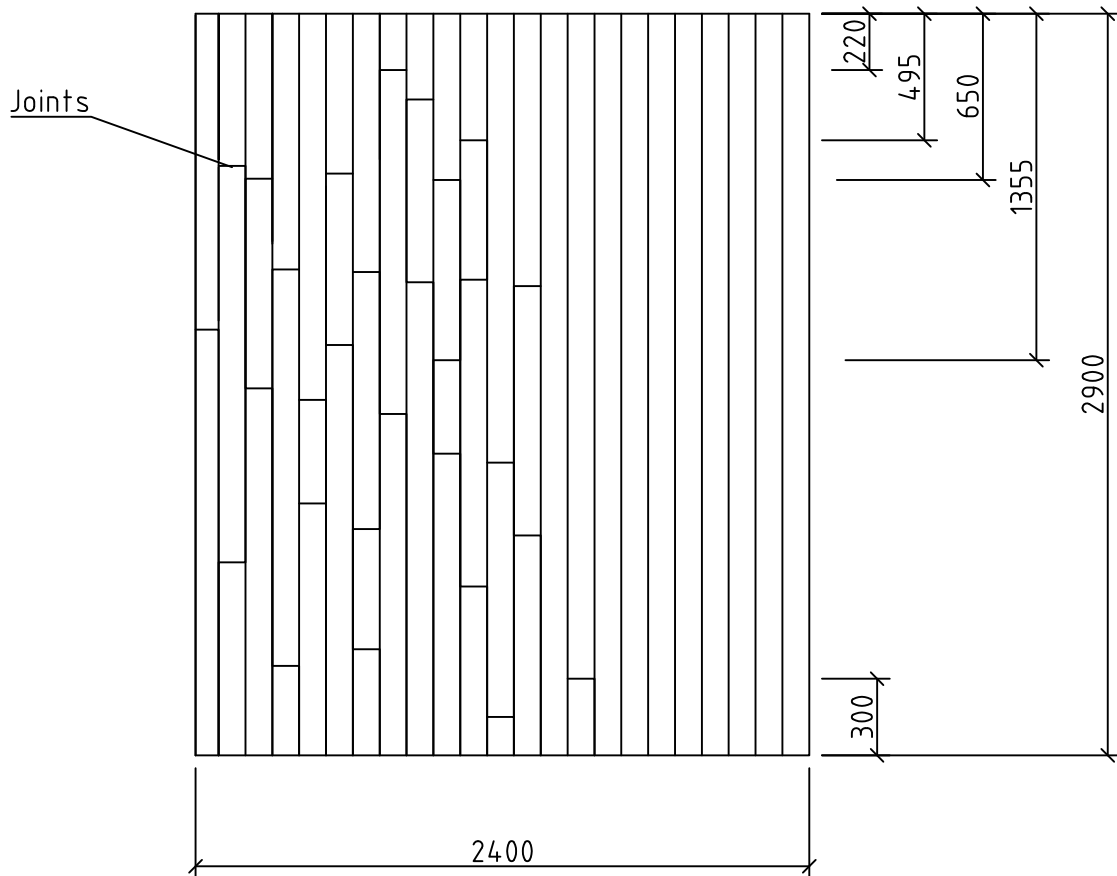
The test arrangement is shown in appendices 1-2. In case that the sponsor's drawings and specifications fail to correspond with the construction SP has crossed details or altered the drawings and specifications.

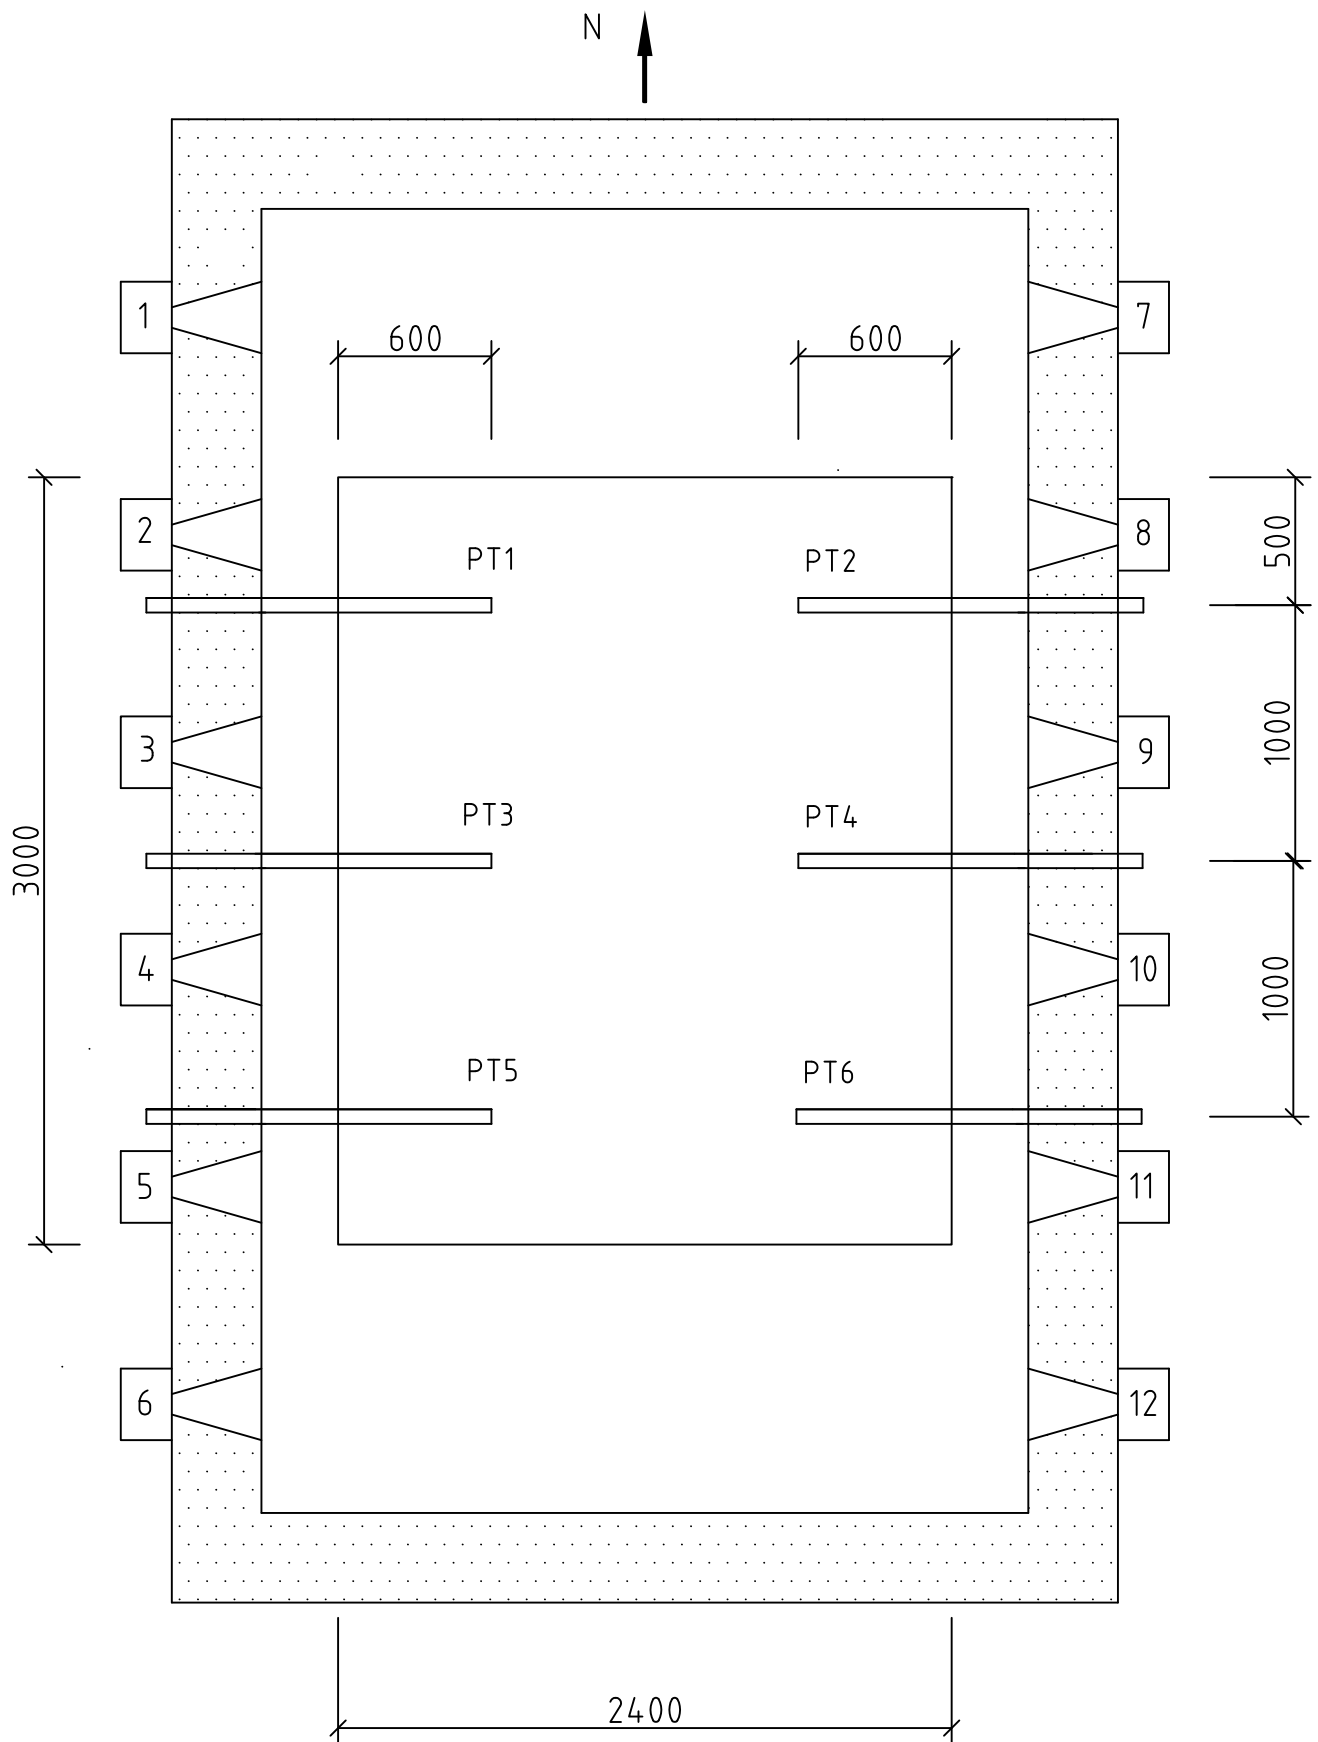
- PT: Plate thermocouples  
The plate thermocouples are placed 100 mm from the fire exposed side of the test specimen

The furnace temperature was measured with 6 plate thermometers (PT1 – PT6). The measuring junctions were positioned approximately 100 mm from the fire exposed surface of the test specimen at the commencement of the test. The positioning is described in appendix 3.

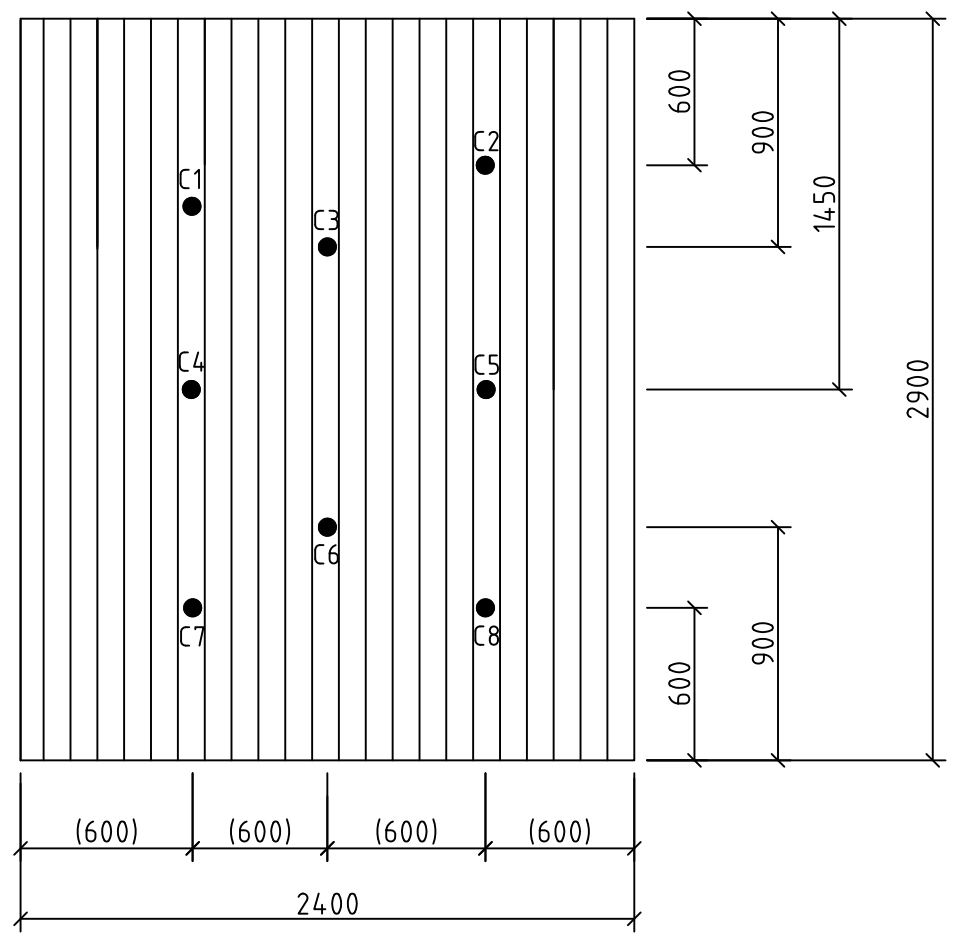
● Thermocouple C1-C8 on the substrate

Approximate locations above. The thermocouples were mounted on half the width of each panel and 100 mm from any short-end joint.

The temperature rise on the surface of the substrate was measured with 8 thermocouples (C1 – C8). The thermocouples were positioned as shown in appendix 9.

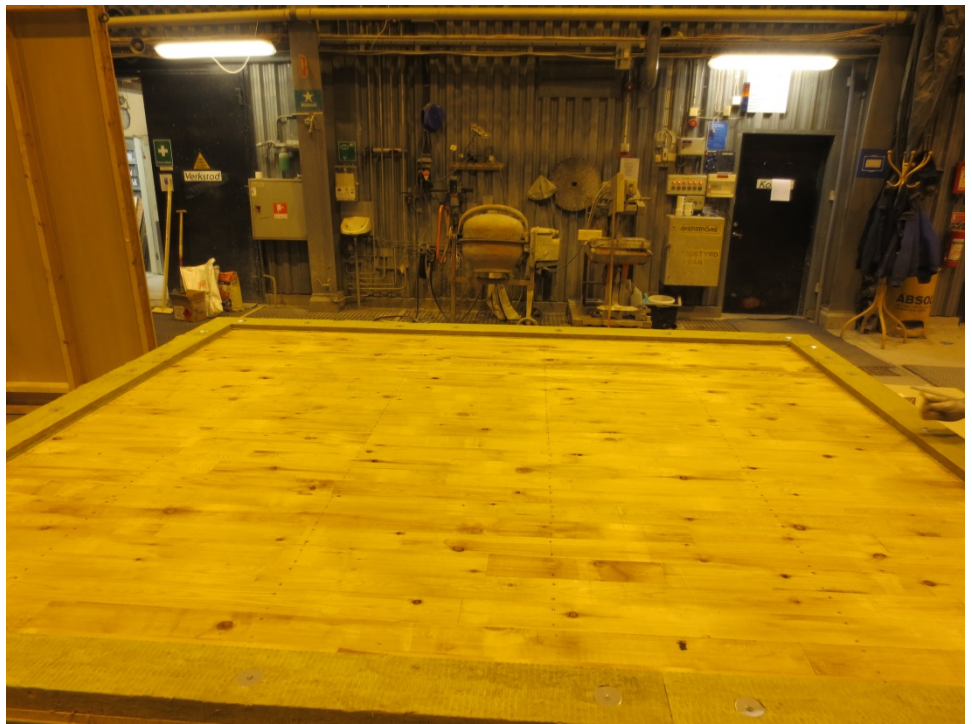
Photo No: 1

The plywood board before  
of the test.

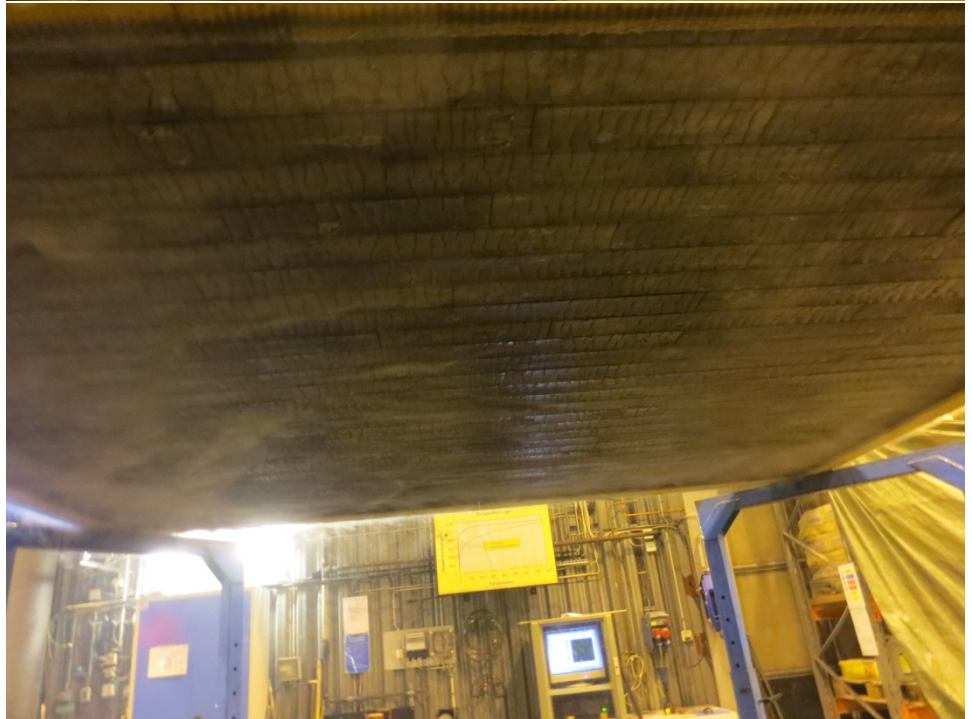
Photo No: 2

The test specimen  
directly after the test.

The fire exposed surface of the covering was charred to a depth of approximately 10 mm into the panel.

There was no burnt material, charred material, melted material or shrunk material at any point of the unexposed side of the covering.

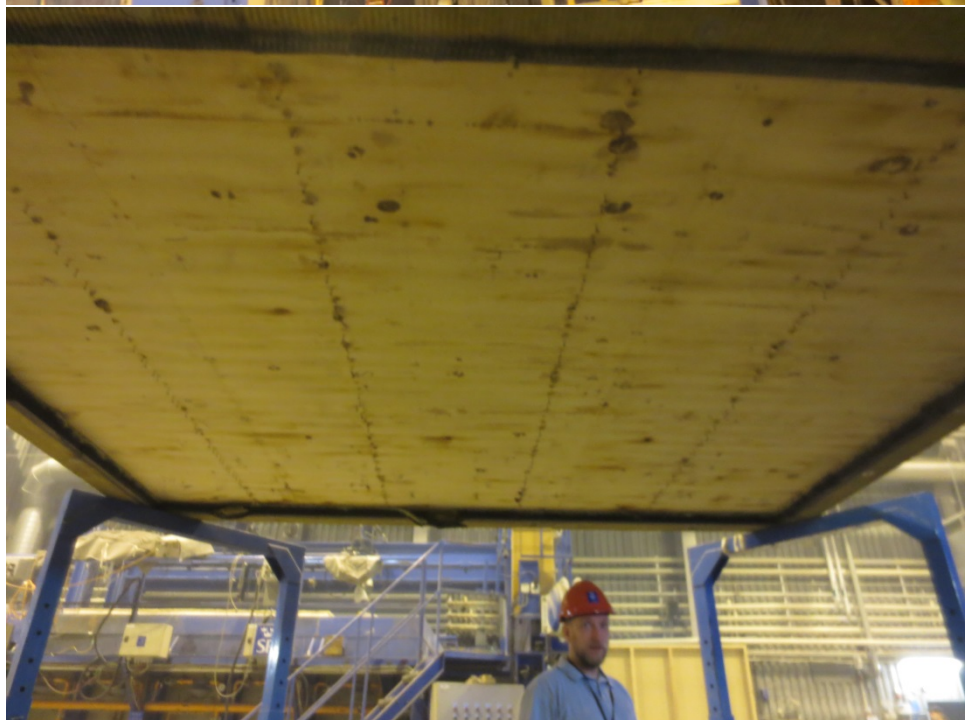
Photo No: 3

The substrate after the test.

The substrate is discoloured behind the tongue and grooves and behind the longitude joints at some points. There is no burnt material, charred material, melted material or shrunk material at any point of the substrate.
